Staircases

Acoustic Stair System

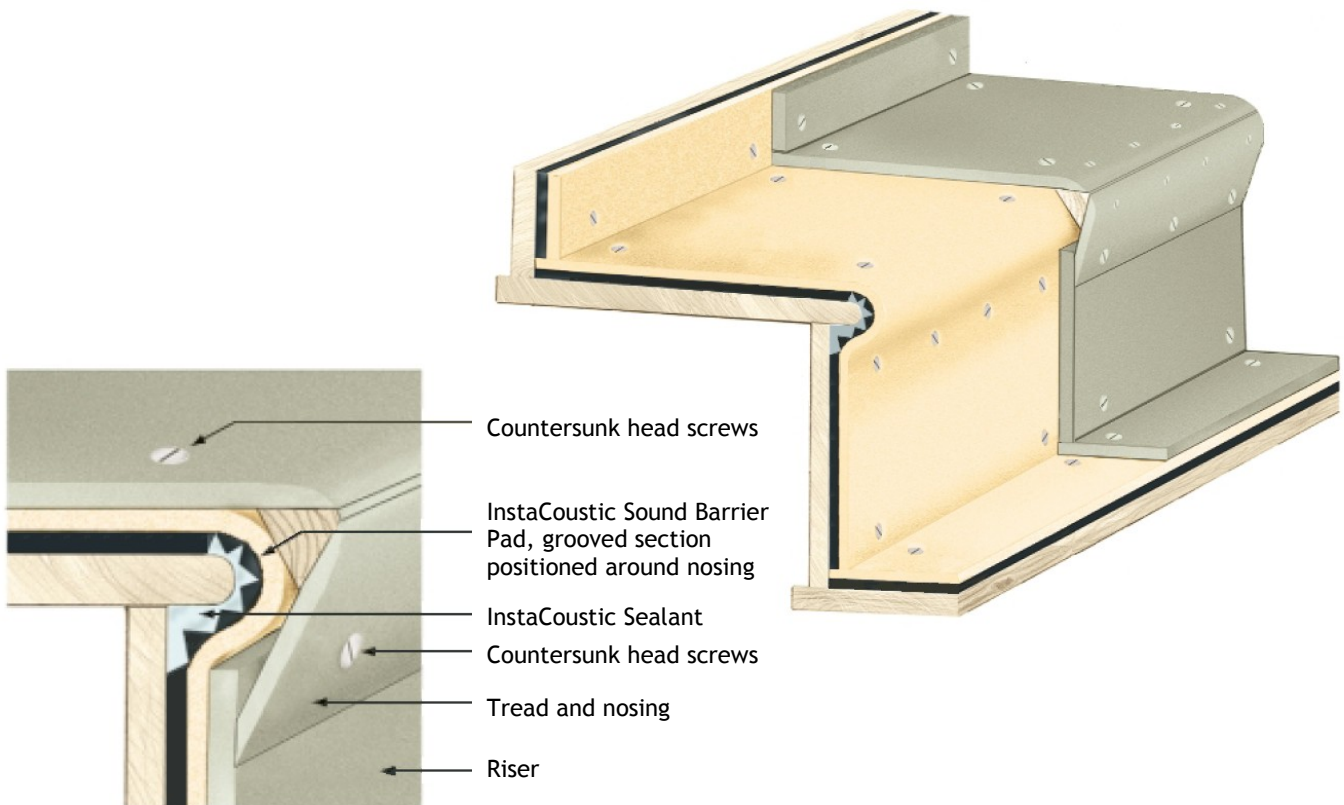
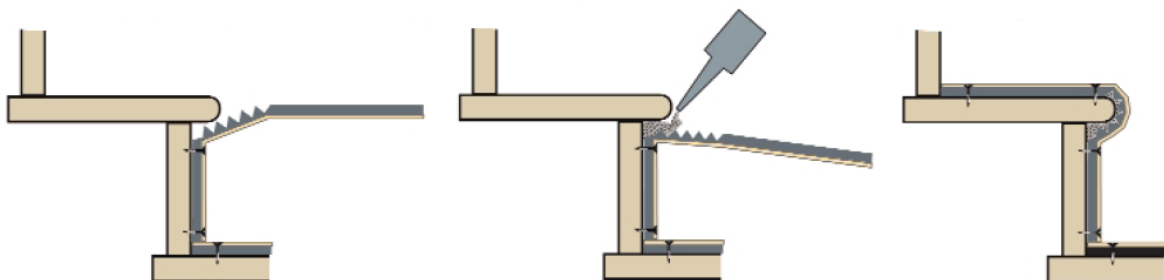
Problem - Treat existing staircase in conversion to reduce sound and prevent trip hazard

Solution - InstaCoustic stair system

Staircase that is receiving the 108, 208 OR H203 stair system must be:

- Free of all debris and sharp objects
- Loose or creaking stairs must be screwed down and gaps sealed
